APPRAISAL FAMILY: WHEEL LOADER

| Manufacturer: AA | Model: 966M | S/N: 0KJP00531 |
| Year: 2014 | Eng S/N: SYE00997 | Trans S/N: KPD02668 |

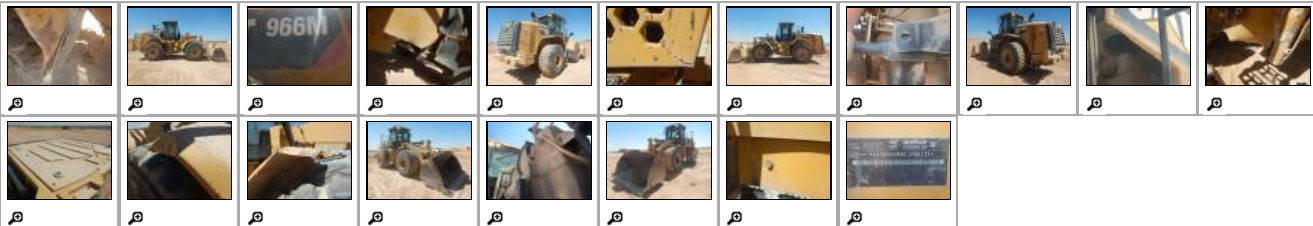
| | CODE | REMARKS |
|---|---|---|
| Shroud | Fair | Hardware is missing from air dam - air dam is damaged - would only replace hardware |
| Hood / Stack | Poor | Engine side panels are fretting along bottom edges - no repairs - tail hood side panel is damaged |
| Fenders | Fair | Fenders are damaged |
| Guards / Screens | Poor | Transmission filter house and door are damaged beyond an economical repair |

Repairs Needed: Fenders - filter house - tail hood side panel - dogbone - left turn indicator - airdam - hydraulic oil leaks

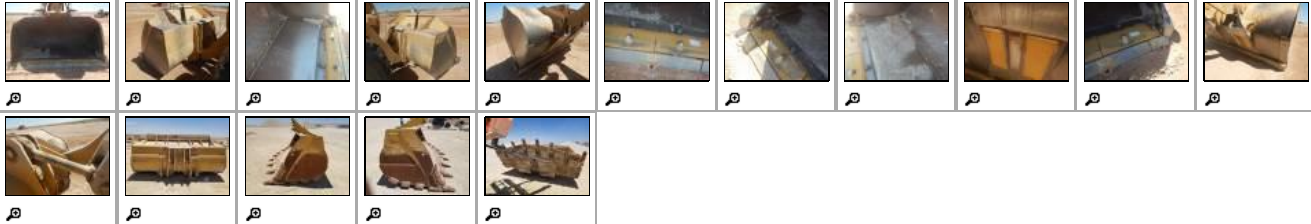
Notes Heavy duty wear packages - both are in good shape
